DEPARTMENT OF TRANSPORTATION

Contract #: 04-0120F4Cty: SF/ALA Rte: 80 PM: 13.2/13.9File #: 69.28**WELDING INSPECTION REPORT****Resident Engineer:** Pursell, Gary**Address:** 333 Burma Road**City:** Oakland, CA 94607**Report No:** WIR-006585**Date Inspected:** 21-Apr-2009**Project Name:** SAS Superstructure**OSM Arrival Time:** 1845**Prime Contractor:** American Bridge/Fluor Enterprises, a JV**OSM Departure Time:** 645**Contractor:** Zhenhua Port Machinery Company, Ltd (ZPMC), Changxing Island **Location:** Shanghai, China**CWI Name:** Chen Xi**CWI Present:** Yes No**Inspected CWI report:** Yes No N/A**Rod Oven in Use:** Yes No N/A**Electrode to specification:** Yes No N/A**Weld Procedures Followed:** Yes No N/A**Qualified Welders:** Yes No N/A**Verified Joint Fit-up:** Yes No N/A**Approved Drawings:** Yes No N/A**Approved WPS:** Yes No N/A**Delayed / Cancelled:** Yes No N/A**Bridge No:** 34-0006**Component:** OBG and Tower**Summary of Items Observed:**

WELDING INSPECTION REPORT

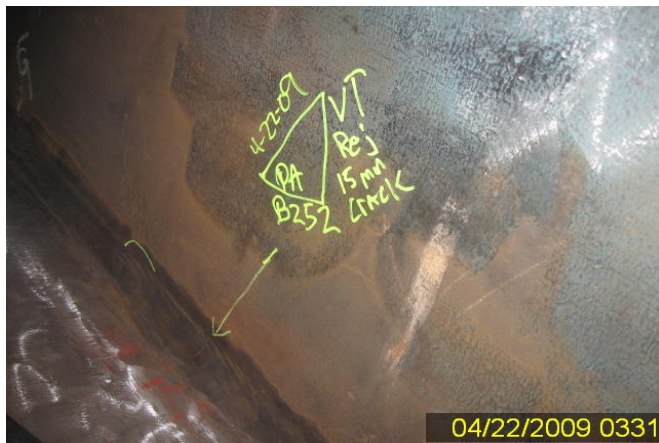
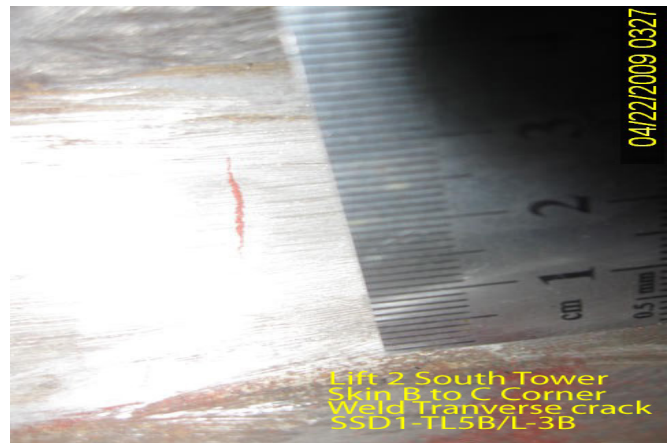
This QA inspector received NDT Inspection Notification Sheet 002739 for Quality Assurance verification of Visual Testing (VT), Magnetic Particle Testing (MT) of South Tower Lift 2 Skin C to B corner weld joint, SSD1-TL5B/L-3B. QA performed Visual inspection and found an area that appeared to be a transverse crack between the 56 and 59 meter diaphragms. Caltrans QA verified the crack with Magnetic particle testing and found on more transverse crack within the 56 and and 59 meter diaphragms. ZPMC QC stated that MT was not performed in this area as the requirement for this weld is 25% of the weld length. Please see the attached photos below of the above mentioned Tower crack. An incident report was issued for on this date the transverse cracks found.
